# ISSMGE Bulletin

Volume 5, Issue 2  
April 2011

### Geotechnical Damage due to the 2011 Christchurch, New Zealand

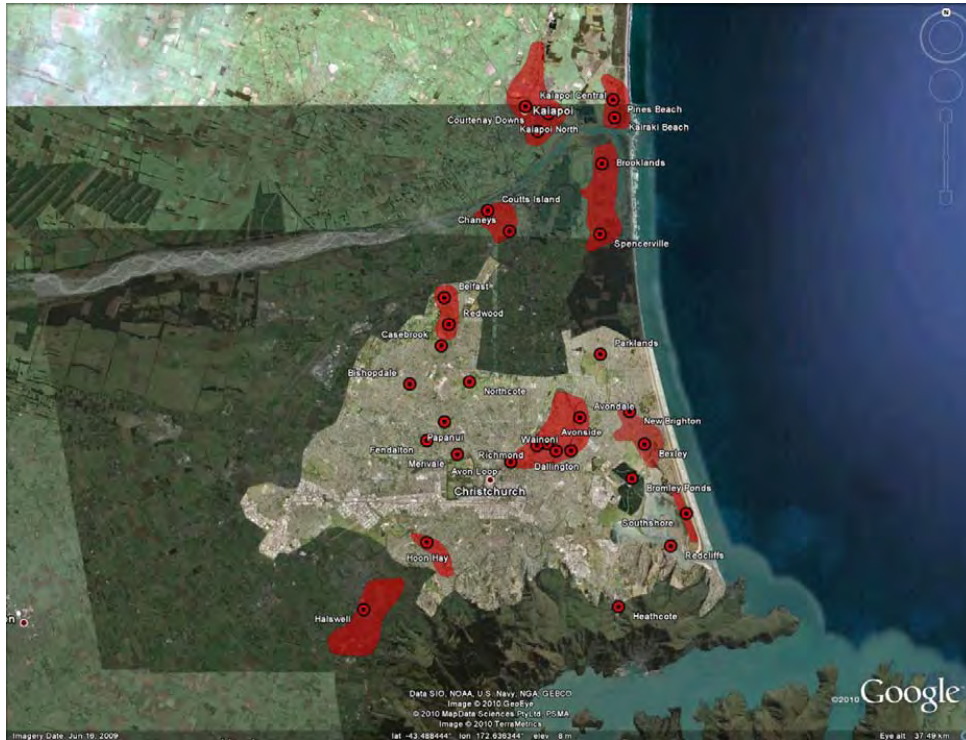
Figure 7. Areas of liquefaction (red shaded regions and red points) in Christchurch and Kaiapoi caused by the 2010 Darfield Earthquake (Cubrinovski et al, 2010).

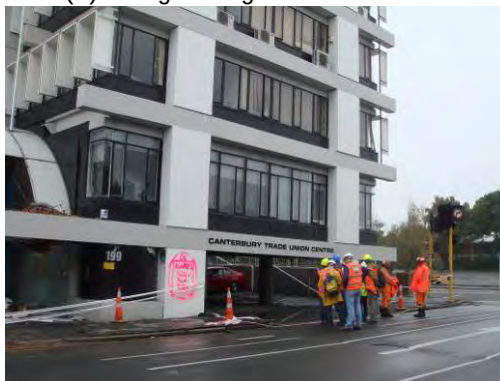
(a) along Kilmore Street

(b) along Armagh Street

Figure 11. Liquefaction-induced damages in CBD.

In the Central Business District (CBD), several buildings collapsed, while many of the buildings that survived suffered significant or some form of structural damage. Severe liquefaction was also observed in the CBD, such as along Kilmore Street (Figure 11a) and Armagh Street (Figure 11b). The relation between the building structural damages and liquefaction of the foundation ground is currently under investigation.

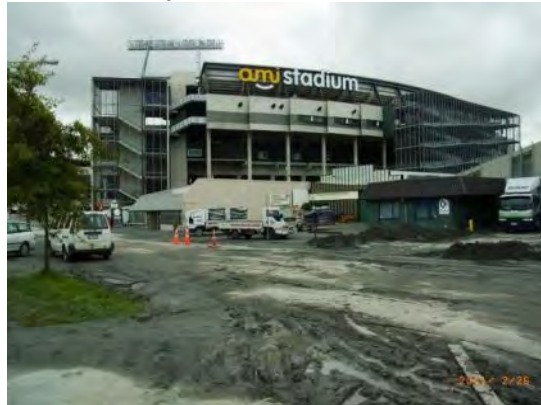
(a) Massive amount of sand ejecta in front of the west stand of AMI stadium.

(b) The ground in front of the east stand of AMI stadium. The green turf was not covered by sand boils.

Figure 12. Liquefaction adjacent to AMI stadium.

There are very few structures in the area where liquefaction countermeasures have been implemented in the foundation ground. One example is the AMI stadium located near CBD, where the ground under the east stand was stabilized with stone column. Minor liquefaction was observed near the east stand in spite of the severe liquefaction all around the stadium (Figure 12).

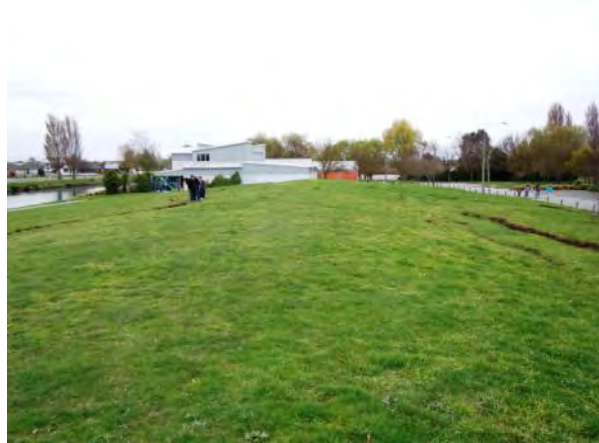
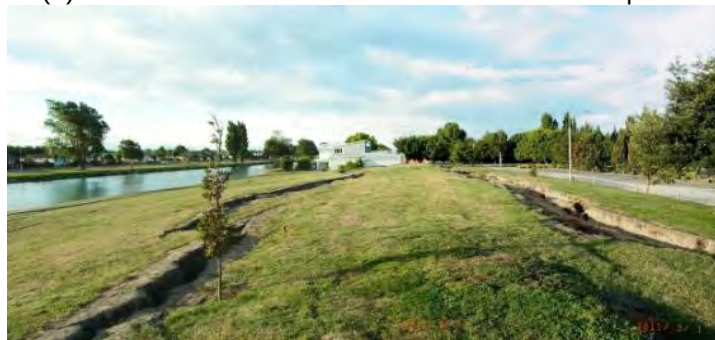
(a) Damage in Porritt Park after 2010 Darfield Earthquake (JGS, 2010)

(b) Same area after the 2011 Christchurch Earthquake

Figure 13. Lateral spreading and the crown settlement of a stop bank near Porritt Park.

Because of short time interval between the two gigantic earthquake events, the earthquake caused additional damages to many facilities which suffered liquefaction-induced damage and had not been repaired. Figures 13 (a) and (b) are photos of a river embankment in Porritt Park (east bank of Avon River), after the 2010 earthquake and 2011 earthquake, respectively. The width of crack openings on the shoulder and settlement of the crown became larger due to repeated liquefaction of the foundation ground of the embankment. Extensive repeated liquefaction was observed in entire Porritt Park, where half of green grassy area was covered by sand boils again following the previous earthquake.

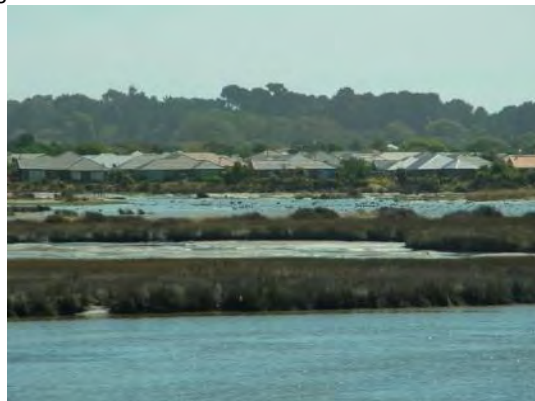
Figure 14. A photo overlooking the Bexley residential area.

Extensive liquefaction was observed widely in residential areas along Avon River. The very shallow ground water table (1.0m to 1.5m) has been recognized in western suburb of Christchurch, particularly in areas close to the coastal line. Bexley is a newly constructed residential area developed by reclaiming the wetland near the mouth of Avon River. Figure 14 shows a broad panorama overlooking Bexley, taken from the South Brighton Bridge crossing the river mouth of Avon. It can be seen that residential houses are now located on an area where the ground elevation is almost the same as the water surface.

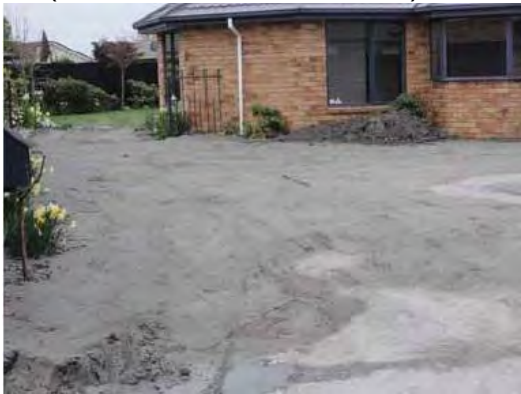
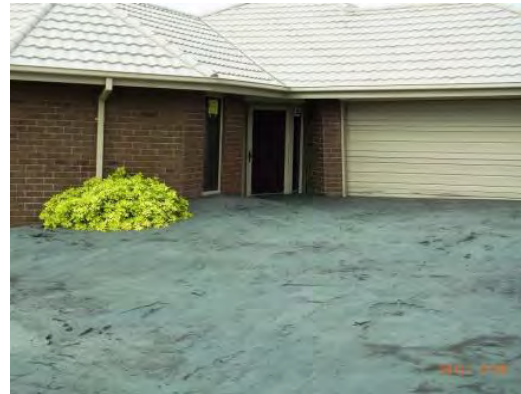
(a) After the 2010 Darfield Earthquake  
(Cubrinovski and Orense, 2010)

(b) after the 2011 Christchurch Earthquake

Figure 15. Damage to residential houses due to repeated liquefaction in Seabreeze Close, Bexley.

In Bexley, a large number of residential houses/properties suffered severe damage from liquefaction in September 2010 earthquake. After the 2011 earthquake, it was again one of the worst hit areas in terms of liquefaction-induced damage. Figures 15 (a) and (b) show damaged residences after the 2010 and 2011 earthquakes, at Seabreeze Close in Bexley. Massive amount of sands were ejected and deposited around the houses. Differential ground settlement was caused by severe sand boils, resulting in tilting in many houses.

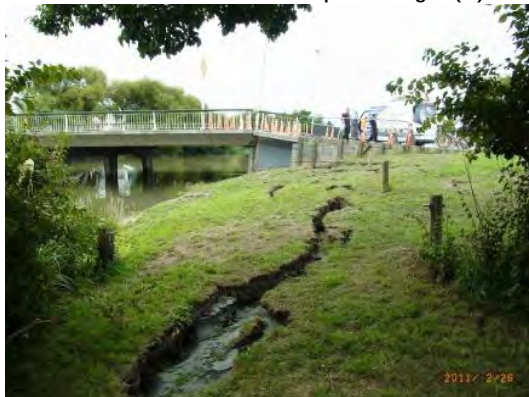
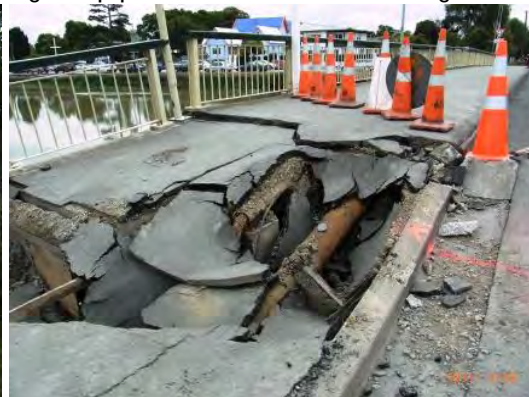
(a) Tilt in abutment due to lateral spreading

(b) Damage to pipeline installed in the bridge

Figure 16. Damage to bridge crossing the Avon River (Avondale Road).

Damages in levees along Avon River were observed everywhere, spanning from inside the CBD to the river mouth. Many bridges crossing the Avon river suffered tilting in their abutments, as a result of lateral spreading and loss of bearing capacity due to liquefaction (Figure 16a). Damage to pipelines was also observed at the connections between bridge and backfill. In most cases, the settlement of the bridge abutment itself is smaller than that of the adjacent soil because the bridge is supported by pile foundations (Figure 16b).

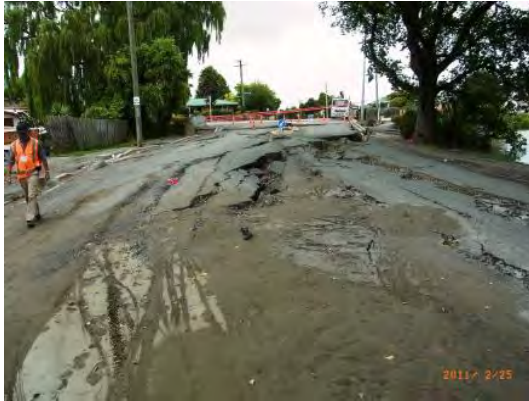
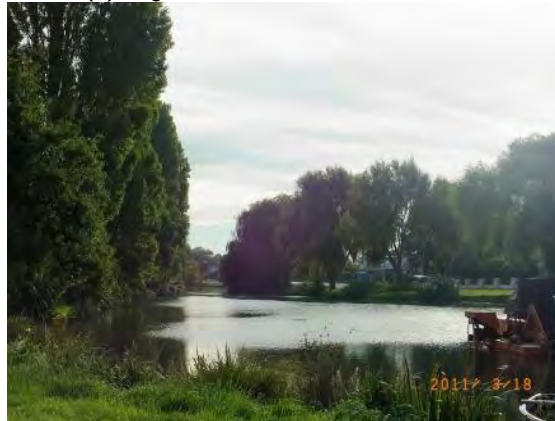
(a) River dike moved laterally toward the river

(b) River bed appeared above water surface as lateral spreading pushed up the river bed

(c) High water level in Avon River

Figure 17. Ground distortions due to liquefaction along Avon River.

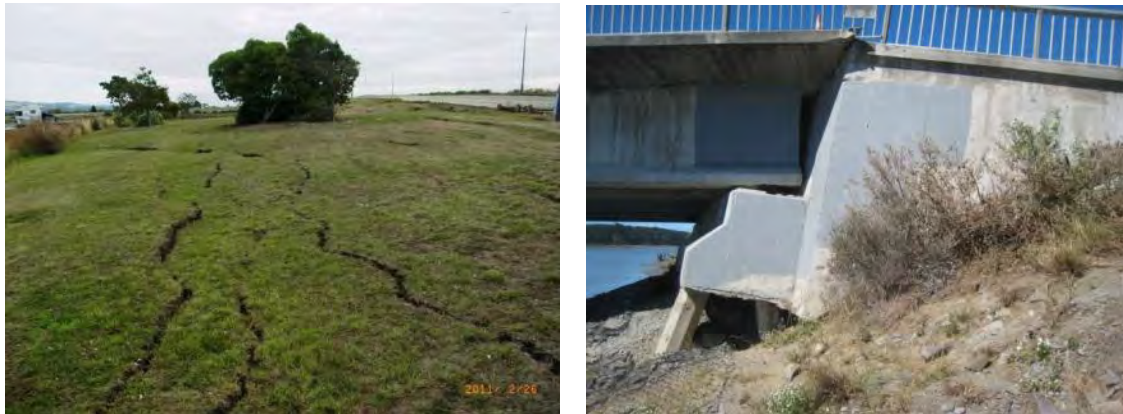
(a) Damage to the body of the embankment (b) Tilted abutment and protruding battered pile foundation

Figure 18. Liquefaction-induced damage to South Brighton Bridge.

The South Brighton Bridge which crosses the mouth of Avon River was severely affected by liquefaction on ground basement. Observed damages near the bridge were lateral deformation and crown settlement in the bridge approach, large tilt of abutments, tension and compression cracks in pile foundations and failure of pipeline installed underneath bridge girder (Figure 18). The body of the embankment spread laterally, with the top settling down due to liquefaction of the ground underneath and causing large tilt of the abutments. The back side of the abutment settled down, the front side lifted up, and the pile foundation protruded to the ground surface. Tension and compression cracks were observed in the battered pile foundation; however no pile was broken. Thus, it can be considered that the loss of lateral bearing capacity of the pile foundation was induced by liquefaction below the abutment.

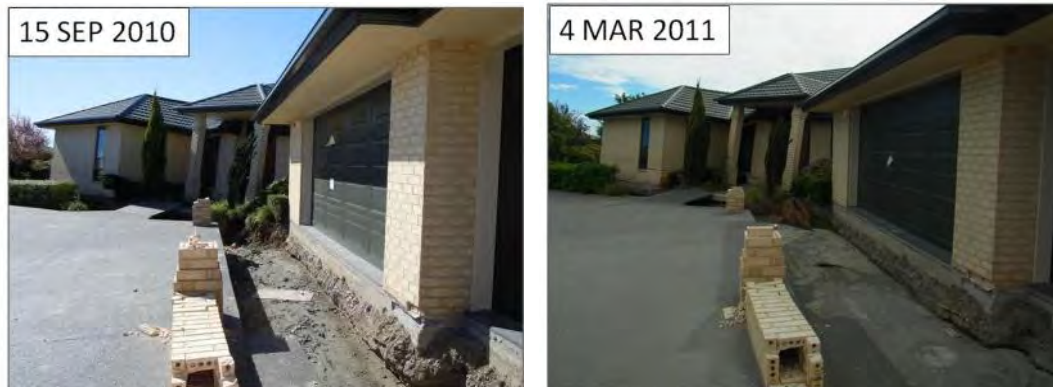
Figure 19. Minor additional damage to a residential house which underwent foundation failure due to lateral spreading and liquefaction in 2010 Darfield Earthquake. (South Kaiapoi)

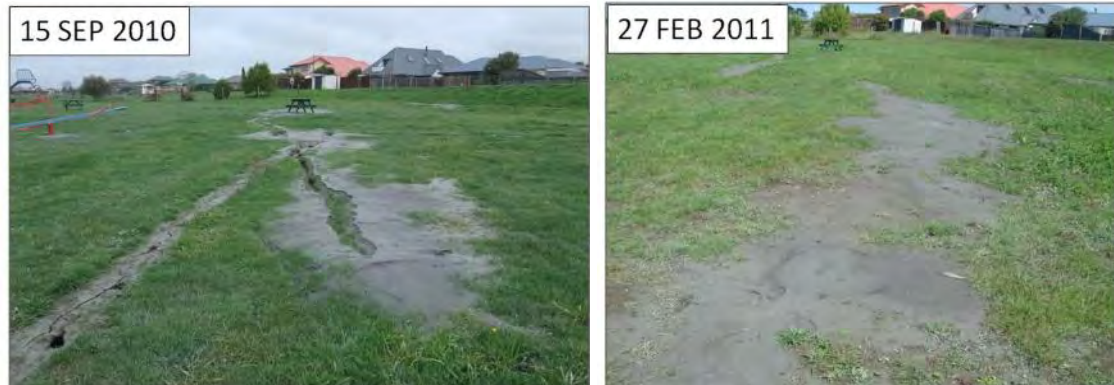
Figure 20. Repeated liquefaction at a park adjacent to Courtenay Lake (South Kaiapoi). Liquefied soil was ejected from existing cracks, but ground distortion was minor compared to the ones observed in September 2010 earthquake.

In areas close to the waterways, most of sand boils were observed at existing/repairs cracks caused by the 2010 earthquake. Aside from the lower intensity of ground shaking in Kaiapoi, it is possible that the excess pore water pressure generated by the earthquake motion could have been dissipated easily through the existing cracks and therefore, significant ground distortion was not caused by this earthquake (Figure 20 and 21).

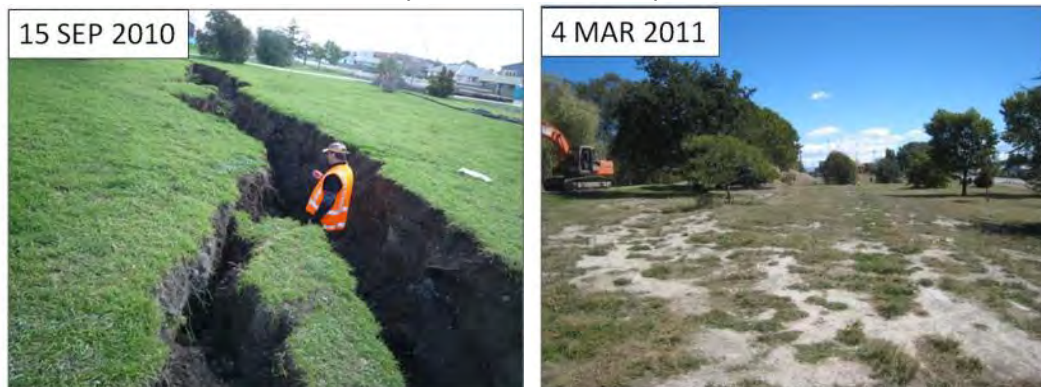
Figure 21. Damage to the stop bank along Kaiapoi river (North Kaiapoi). Sand boils were observed on restored cracks. The damage to the stop bank was minor and lots of small fissures were observed at restored cracks.

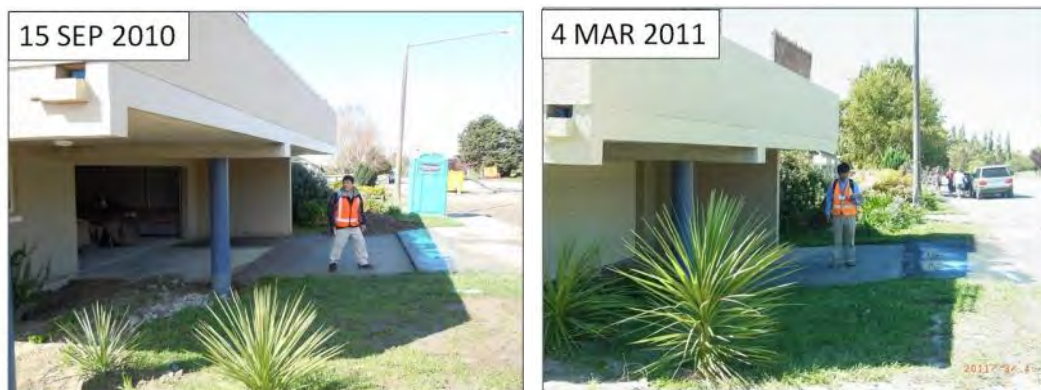
Figure 22. Further subsidence in two-story house neighboring the stop bank. (North Kaiapoi)

Figure 22 is comparative photos of settlement of a two-story house due to liquefaction. The slope in front of the garage was originally uphill, but it became a downhill after 2010 Darfield earthquake as a result of more than 50 cm of ground subsidence. This house suffered additional 15 cm of subsidence from the 2011 earthquake. The narrowing gap between the roof and the head of a member of the research team can be recognized from the figure. Although the investigators appearing in the photos are actually different, their heights are almost the same.

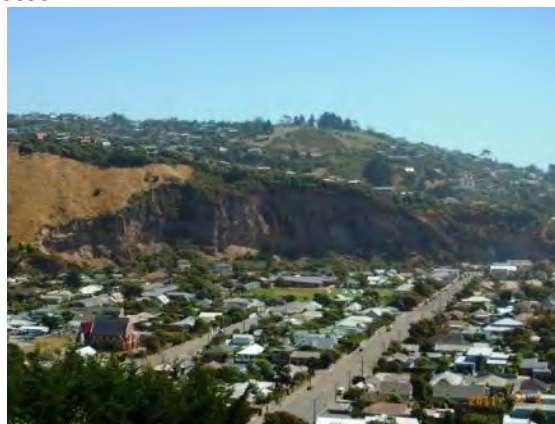
Figure 27. Panoramic view of a disturbed cliff (Sumner).

Figure 27 shows a landscape of the affected cliff located at the west side of Wakefield Avenue in Sumner. This cliff is approximately 70 m high and 500 m long in north-south direction. The cliff surface was previously covered with vegetation, but became bare due to earthquake disturbance.

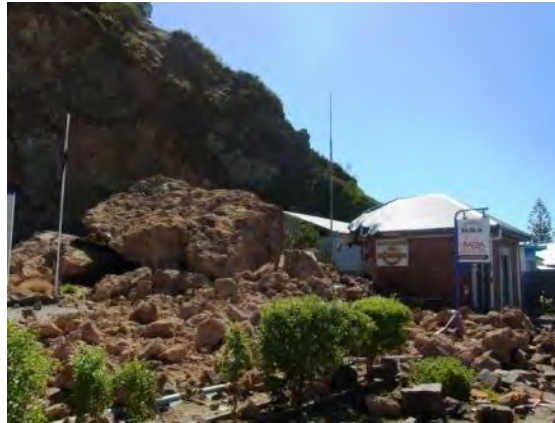
Figure 28. Huge rock fall adjacent to a building (Sumner).

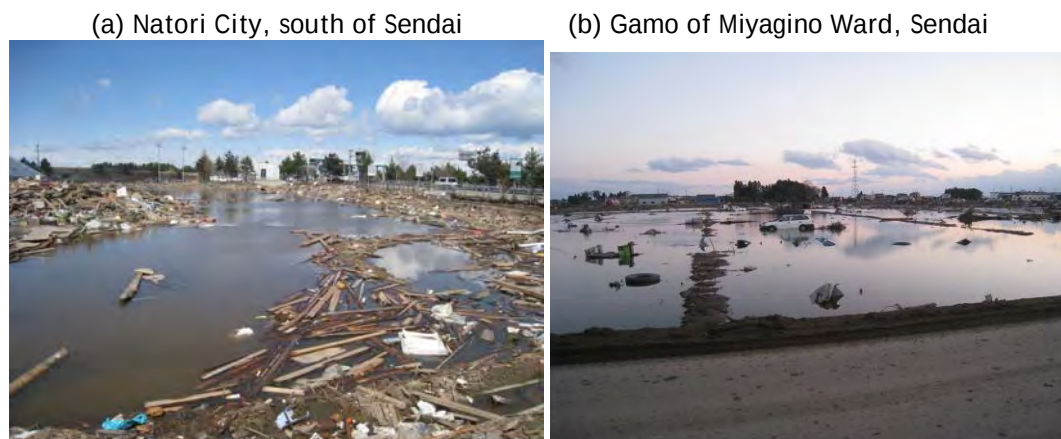
Fig. 2 Coseismic subsidence in Sendai (Photographs by Daiken Suzuki, former student of University of Tokyo)

Geospatial Information Authority of Japan announced that the coseismic displacement of the earth crust in the coastal area was at maximum 5.3 m in the horizontal direction towards the Pacific Ocean and 1.2m in subsidence. Thus, many areas along the affected coastal area got under water, the tsunami effect was made more serious, and the tsunami water remained in the area for a longer time, making the rescue very difficult. Fig. 2 illustrates the coseismic subduction in Sendai area. Note that similar subsidence occurred at many places in the world during past gigantic earthquakes: Kohchi of Japan in 1946 and at several more times in the history, Valdivia and surrounding area in Chile in 1960, South Alaska in 1964, and Izmit Bay of Turkey in 1999. Kohchi and Valdivia came upwards again after the quakes.

The radioactivity discharged from Fukushima I nuclear power plant caused contamination of air, soil, and sea water. Near the power plant, cleaning of contaminated soil will be a very important issue. Similarly, salt contamination of soils in tsunami-hit areas and areas of coseismic subsidence (Fig. 2) will be very important for re-initiation of agriculture. Hopefully, the high rate of annual precipitation will naturally clean up the soil in a short period.

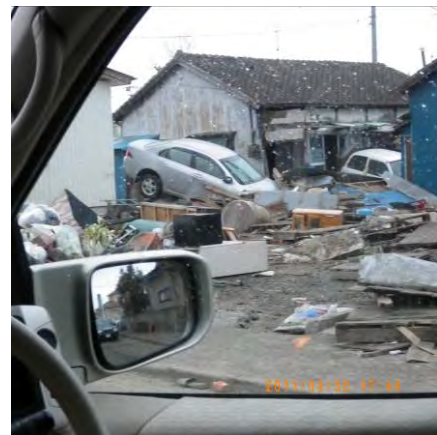
Fig. 9 Tsunami debris in Tagajo Municipality

Tsunami was the most serious type of damage. Because of the sympathy to tsunami victims and their families, engineering societies decided to postpone damage reconnaissance in the affected area unless very necessary. There is, however, minimum information available. First, the height of tsunami was investigated to find that the height was more than 15 m and easily overtopped sea walls that had been constructed against the previously known tsunami height. The destructive power of high tsunami was substantial and removed nearly all the structures in the attacked areas (Fig. 8). This photograph reminds us of Banda Aceh after tsunami disaster in 2004. In this flat land, there is no place for people to evacuate, even if a tsunami alert is issued properly. In some tsunami-affected areas, the sea water remained on shore for many hours and evacuation was made impossible. Prof. Nozomu Yoshida of Tohoku Gakuin University had to take refuge on a pedestrian bridge crossing a street for 12 hours without food and warm overcoat, because the street was inundated until 1 AM. There was a huge amount of debris after tsunami attack (Fig. 9). This debris has to be disposed in an appropriate way, which is a very difficult task.

More problems are pointed out in the field of geoenvironmental engineering. Soil was contaminated by oil in tsunami-affected areas. Cleaning of those soils is urgently needed. Removal of debris and, in particular, tsunami debris (Fig. 9) is another important issue. The total amount of the debris will be as much as 26.7 million tons.

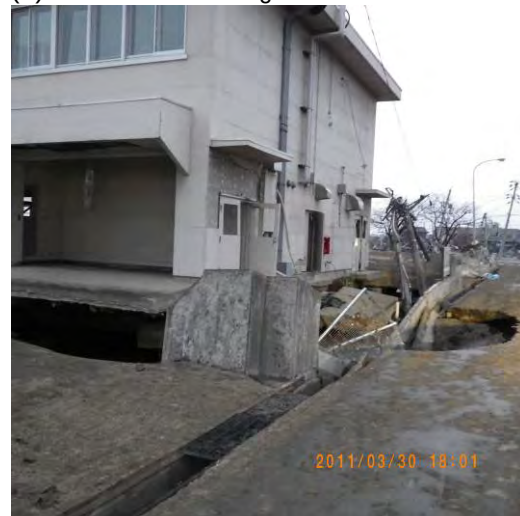
(a) Intact quay wall

(b) Erosion in building foundation

Fig. 10 Post-tsunami situation in Ishinomaki Harbor to the east of Sendai

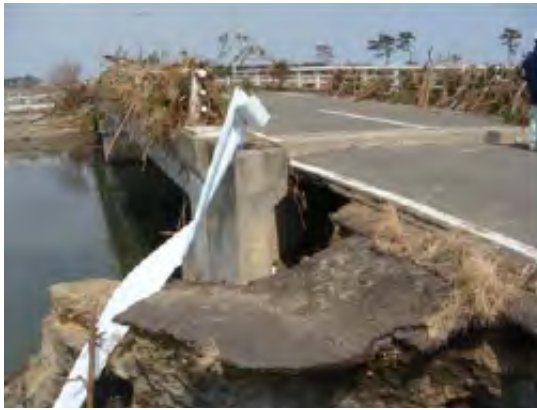
Fig. 11 Erosion of embankment at bridge abutment after tsunami Strike (Iwanuma in Miyagi Prefecture)

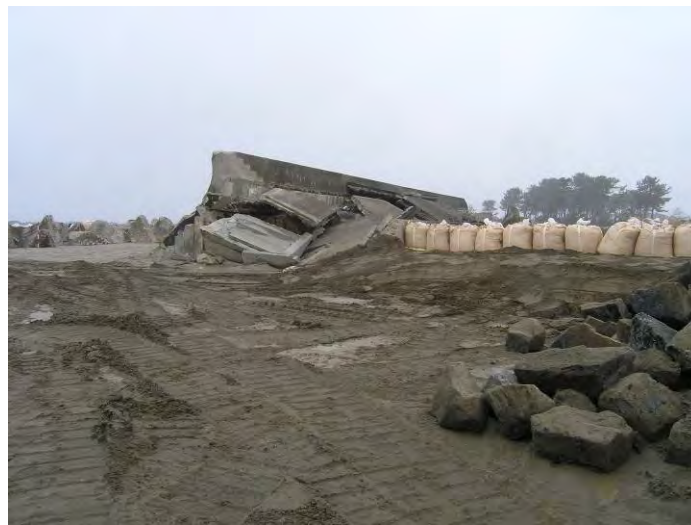
Fig. 13 Destroyed sea wall near Abukuma River mouth

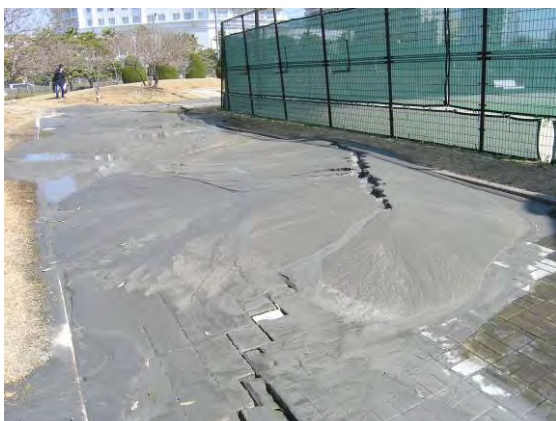
Fig. 14 Liquefaction in Urayasu City of Chiba

Figure 14 illustrates sand boiling, which is an evidence of subsurface liquefaction, in a sports facility in Urayasu City in the east suburb of Tokyo. Land reclamation took place in 1980s in this area. Fig. 15 shows the consolidation settlement of liquefied sand in the same area. Because the building was supported by a pile foundation, no structural damage occurred therein and this shopping mall was able to start business within a few weeks after the quake. It is possible, however, that the differential settlement between the building and the ground destroyed many lifeline connections. Fig. 16 indicates road pavement that distorted substantially because of liquefaction. One important feature of the liquefaction problem is the damage in private properties. Overall liquefaction in residential development in manmade islands caused subsidence and tilting of many houses (Fig. 17). Lack of liquefaction mitigation measure in private lands and houses and their restoration at reasonable cost are now attracting public concern. Moreover, damage to lifeline, which is in particular sewage pipeline, is important. Figs. 18 and 19 demonstrate floating of manholes in Urayasu and another northern city of Sukagawa. Floating and surface subsidence imply need for more efficient compaction of backfill sand. Noteworthy is that quay walls around the manmade islands were maintained stable, being different from those in Niigata (1964) and Port Island in Kobe (1995), and lateral flow of liquefied subsoil did not occur.

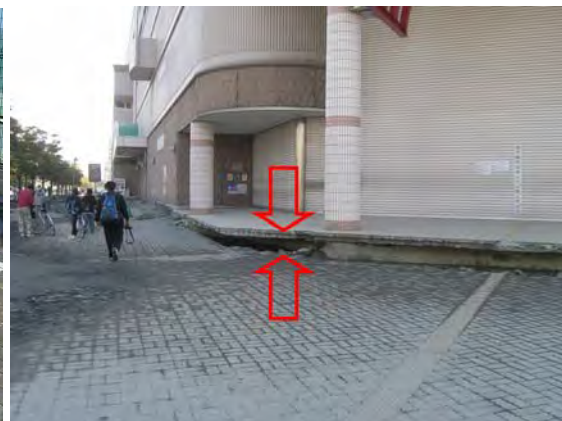
Fig. 15 45-cm subsidence of ground surface in front of a shopping center (Urayasu City)

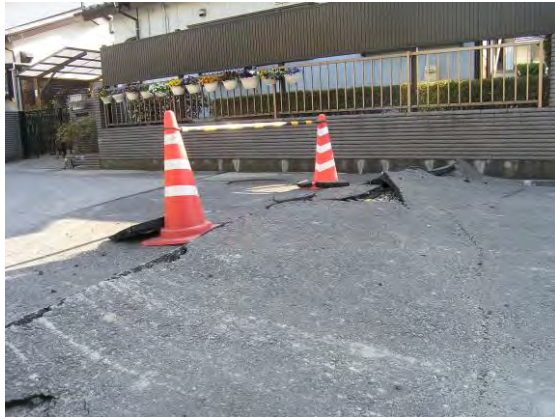
Fig. 16 Distortion of road pavement in residential area (Mihama of Chiba)

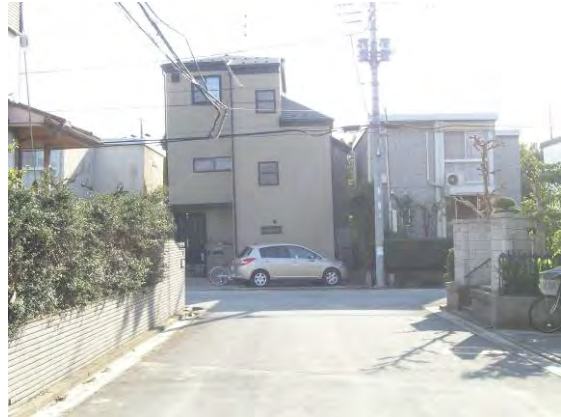
Fig. 17 Tilting of house (Mihama of Chiba)

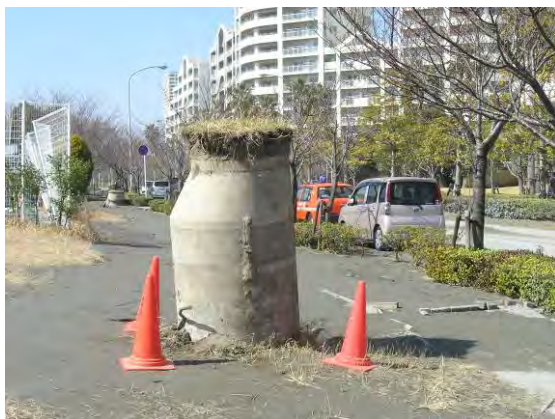
Fig. 18 Uplifting of manhole of 2 meter in Urayasu of Chiba

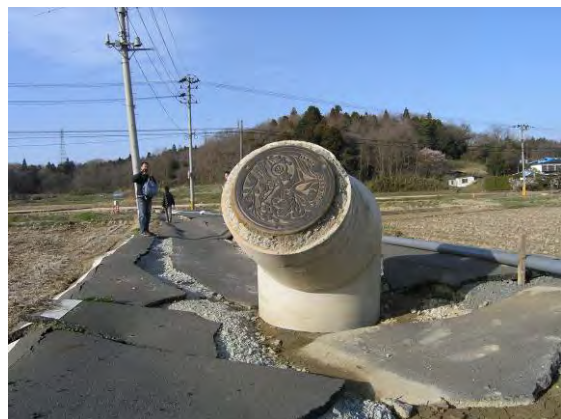
Fig. 19 Uplifting of manhole and surface subsidence in Sukagawa of Fukushima

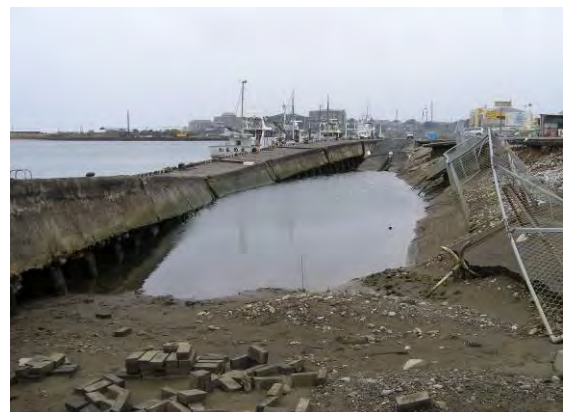
Fig. 20 Damaged quay wall in Nakaminato Harbor

Liquefaction occurred in other areas as well. One part of the sheet piles quay wall at Nakaminato Fishermen's Harbor in Ibaraki Prefecture was distorted as illustrated in Fig. 20. Because this particular place is probably situated upon a small river channel, liquefaction occurred and allowed profound outward displacement of the quay wall and subsidence of the backfill where a later tsunami strike eroded the soil. Figs. 21 and 22 indicate distortion and subsidence of a road embankment and associating uplift at the foot of the slope. Boiled sand obviously verifies the occurrence of liquefaction. It seems that the higher embankment subsided and the lower ground surface came up because of volumetric balance during soil movement. It is noteworthy that the industrial site next to this place did not liquefy probably because of soil improvement.

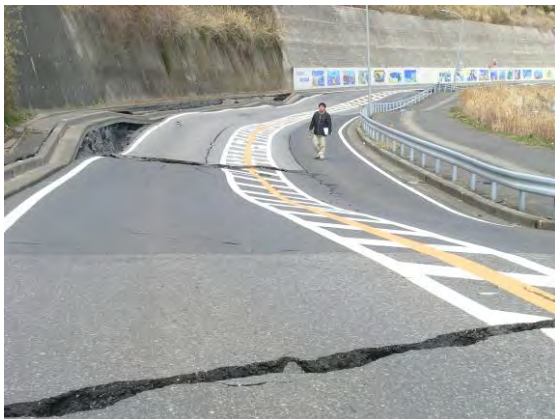
Fig. 21 Distortion of road embankment in Nakaminato of Ibaraki Pref.

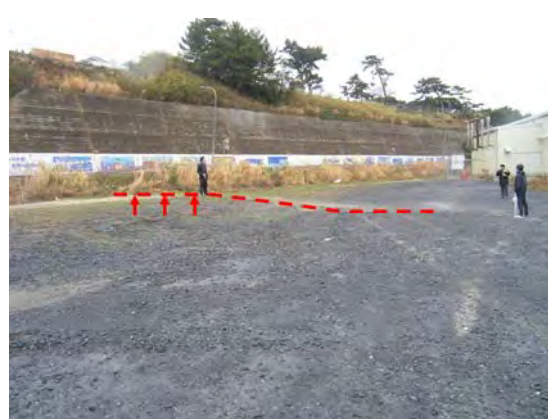
Fig. 22 Uplift near the toe of distorted slope in the previous figure

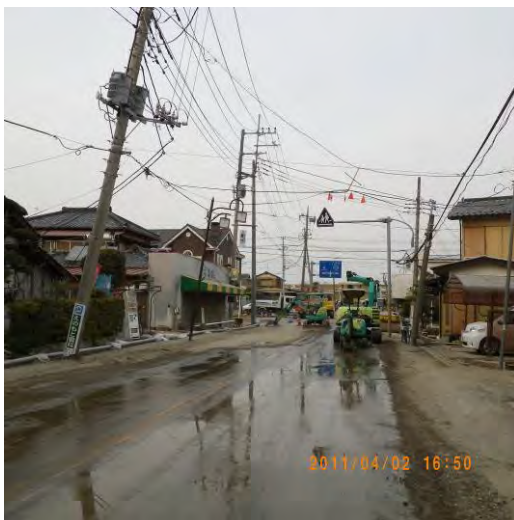
Fig. 23 Liquefaction in residential area of Abiko City (Fusa area)

Urbanization and development of residential area have been conducted out of Tokyo area as well. Fig. 23 indicates house damage in Abiko City of Ibaraki. Liquefaction was concentrated in a small area which used to be a small pond that was filled with sand in 1950s for urban expansion. Liquefaction damage occurred in a residential area in Kuki City (Fig. 24) to the north of Tokyo where originally swampy topography was converted to a residential area.

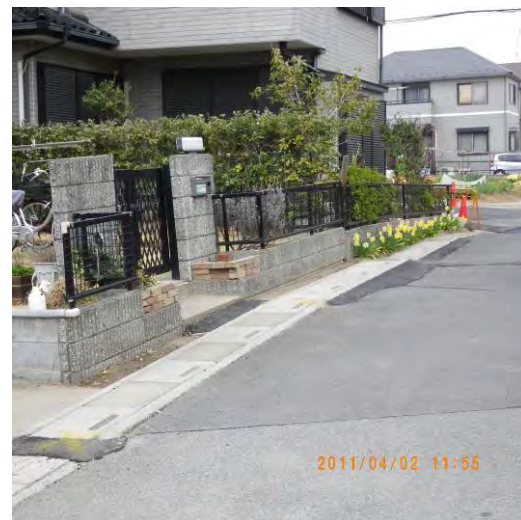
Fig. 24 Liquefaction-induced tilting of house in Kuki City of Saitama Prefecture

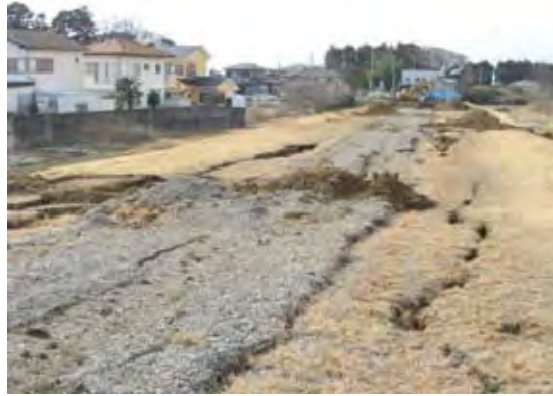
Fig. 25 Liquefaction-induced lateral spread of Naka River levee

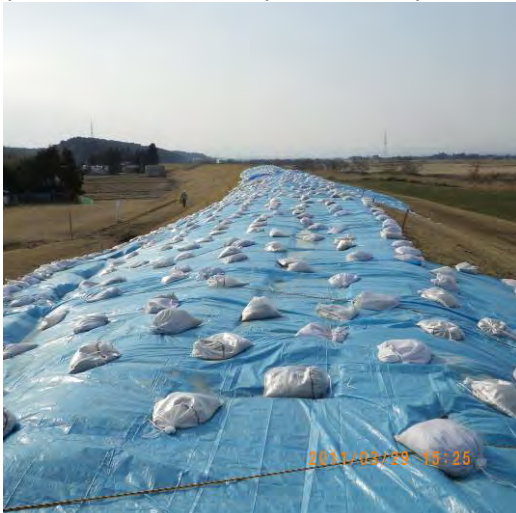
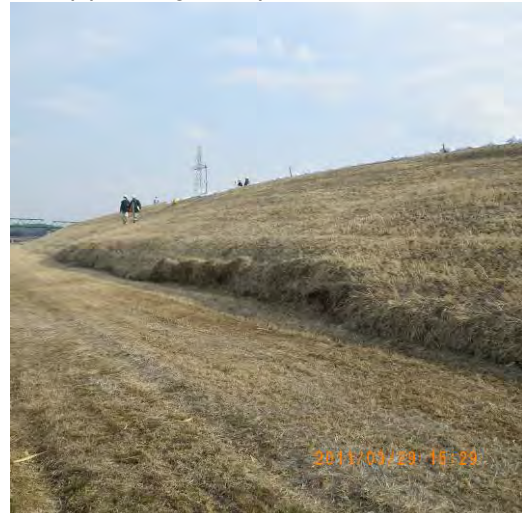
(b) Sliding in slope on river side

Fig. 26 Distortion of Naruse River levee on right bank near 40.0 km post

Figure 26 illustrates significantly distorted levee of Naruse River to the north of Sendai City. Longitudinal deep cracks and sliding of slope towards the toe are remarkable. Liquefaction was found as well on the river side. A very significant subsidence and lateral motion occurred at a levee of Hinuma Lake near Mito (Fig. 27). The entire body of the levee became almost level because of liquefaction at the bottom.

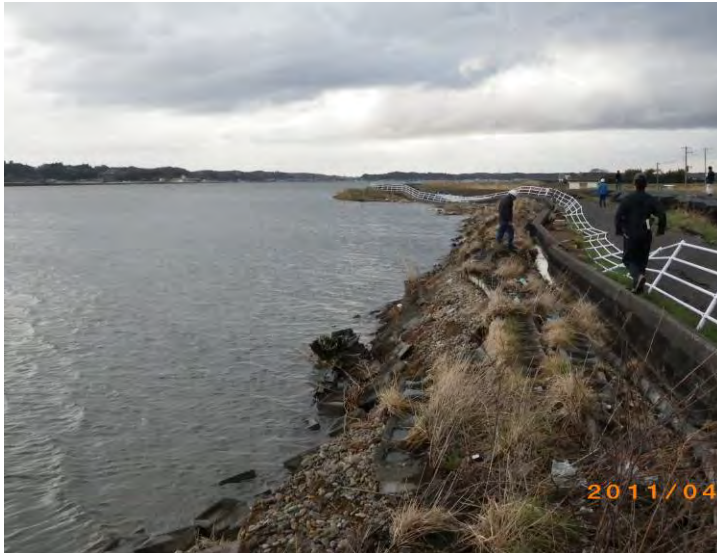
Fig. 27 Flattened Levee of Hinuma Lake near Mito City (Pechanko!)

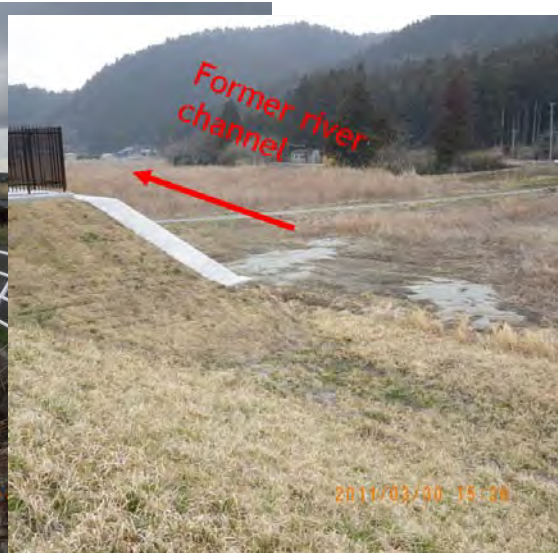
Fig. 28 Repeated liquefaction behind Eai River levee at Kita Wabuchi site

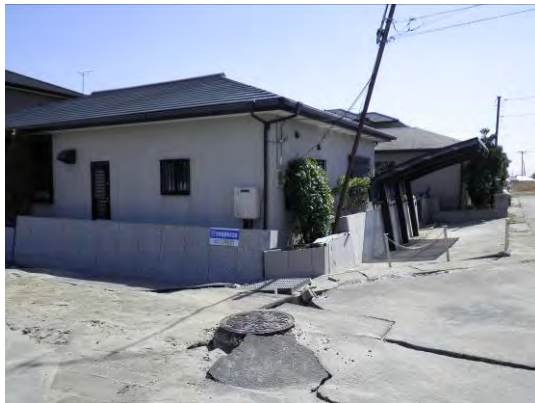
Fig. 29 Liquefaction-induced house damage in Hinode area of Itako City, Ibaraki

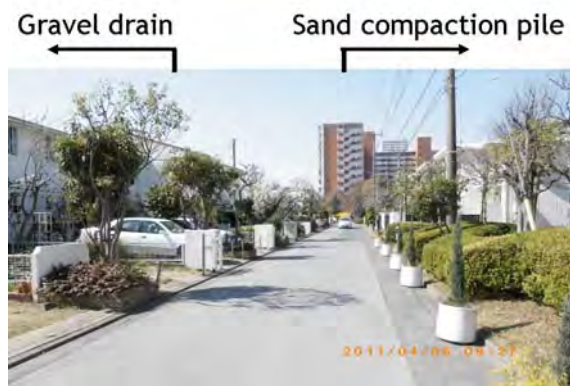
Fig. 30 Successful soil improvement in Irifune-Kita area of Urayasu residential area

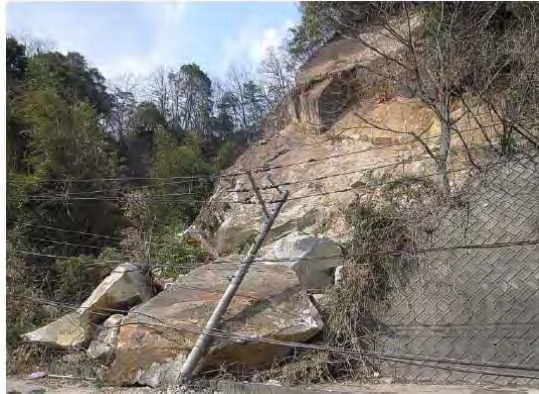
Fig. 31 Rock fall at Ohgo of Ibaraki

Shear failure of slopes and embankments occurred at many places. As far as natural slopes are concerned, the size of failures is not very large. Fig. 31 indicates an example in Ibaraki, north of Tokyo. A bigger slope failure occurred in Shirakawa City of Fukushima Prefecture (Fig. 32). This failure developed within a layer of weathered welded tuff and claimed 13 victims. Noteworthy is the long distance of run-out that suggests the apparent friction angle of 5 degrees approximately. It is necessary to further watch the slope behavior during aftershocks to come and the rainy season.

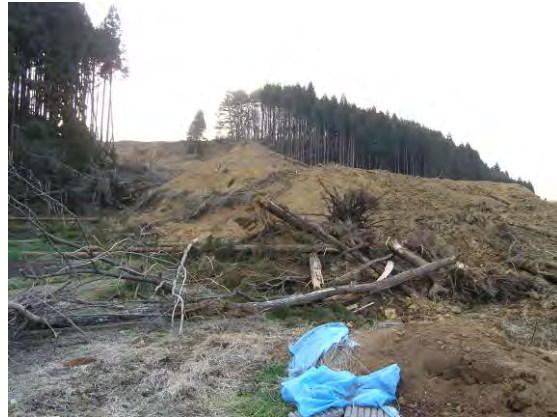
Fig. 32 Failure of natural slope at Hanokodaira of Shirakawa City

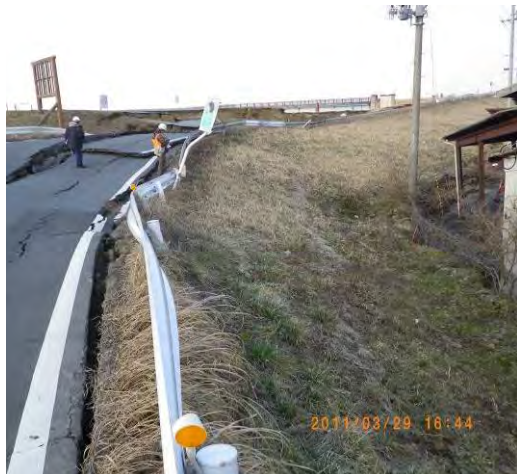
Fig. 33 Distortion of Shida Bridge approach Naruse River, north of Sendai

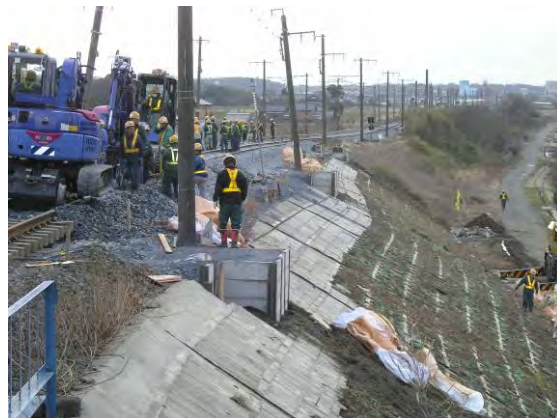
Fig. 34 Distortion of railway embankment (Joban Line of Japanese Railway East, near Mito, Ibaraki)

Distortion of embankment occurred at many places and hindered operation of transportation. Fig. 33 is a distorted road embankment. Fig. 34 shows ongoing restoration of railway truck resting on distorted embankment. Although railway service was stopped for many weeks, the earthquake did not kill any passenger in trains. It is particularly remarkable that the bullet trains (Shinkansen) successfully stopped at the onset of earthquake when they were running at a velocity greater than 200 km/h. This success was achieved by combination of many safety technologies.

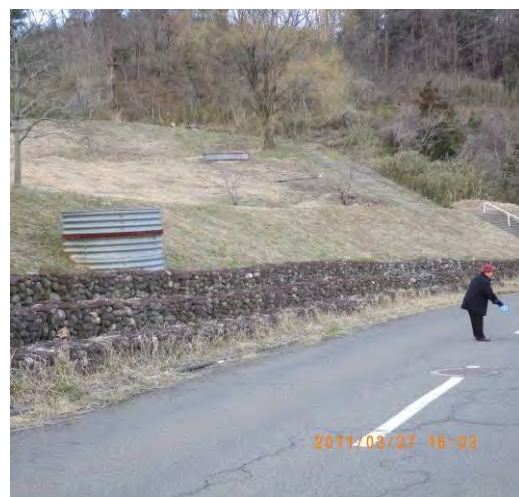
Fig. 35 Slope failure at Midorigaoka of Shiroishi City of Miyagi Prefecture, south of Sendai

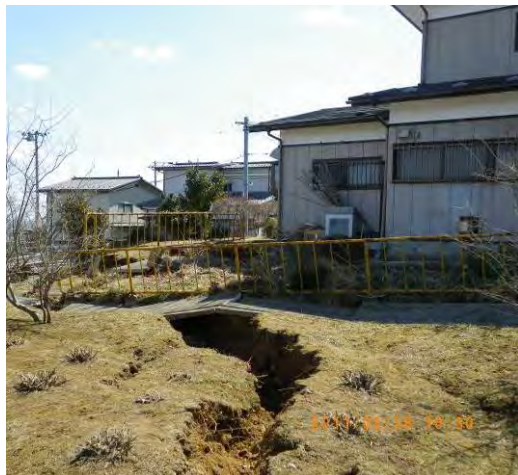
Fig. 36 Failure of residential development slope in Midorigaoka of Sendai City

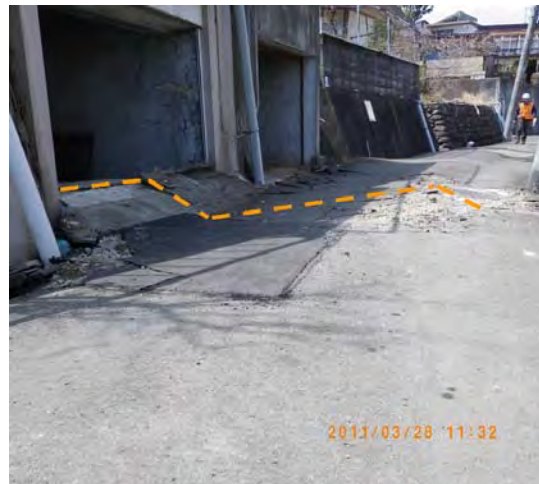
Fig. 37 Compressive distortion of ground surface near bottom of unstable slope (Midorigaoka of Sendai)

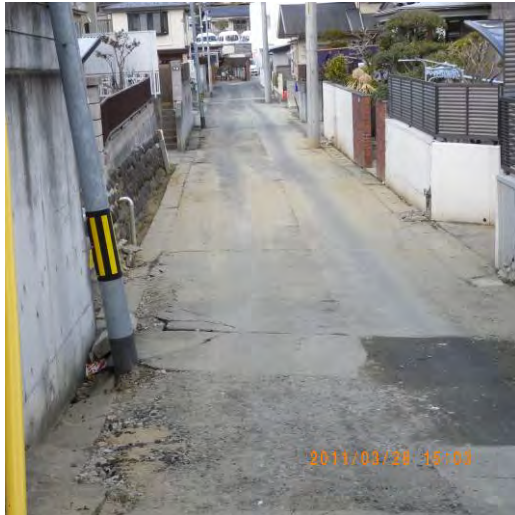
Fig. 38 Soil liquefaction in Asahigaoka 2 of Sendai City

Slope failure was repeated similarly in a land development area in Sendai City. Fig. 36 shows that the slope failure during a future earthquake was feared and this area has been left vacant until the slope failed once more in 2011. This right decision, however, was not made in a nearby area of Fig. 37. This figure indicates that ground was subjected to compressive distortion at the bottom of a moving slope. Fig. 38 shows soil liquefaction in a hilly area of Sendai City. A local person said that there used to be a small stream here and that it was backfilled at the time of land development. Therefore, the mechanism of this liquefaction is similar to what has happened in larger artificial islands near Tokyo.

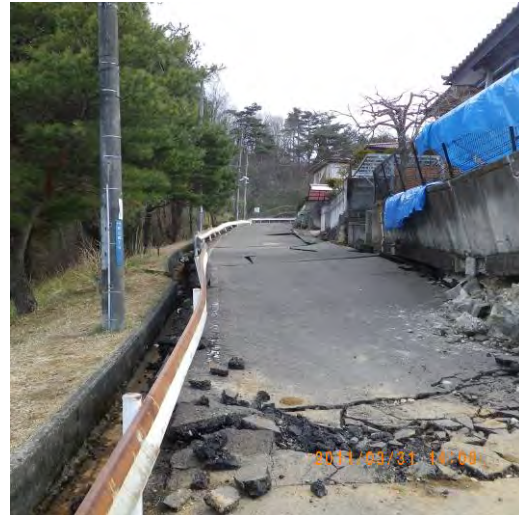
Fig. 39 Damage that was limited to filled part of residential development in hilly area (Oritate 4 of Sendai)

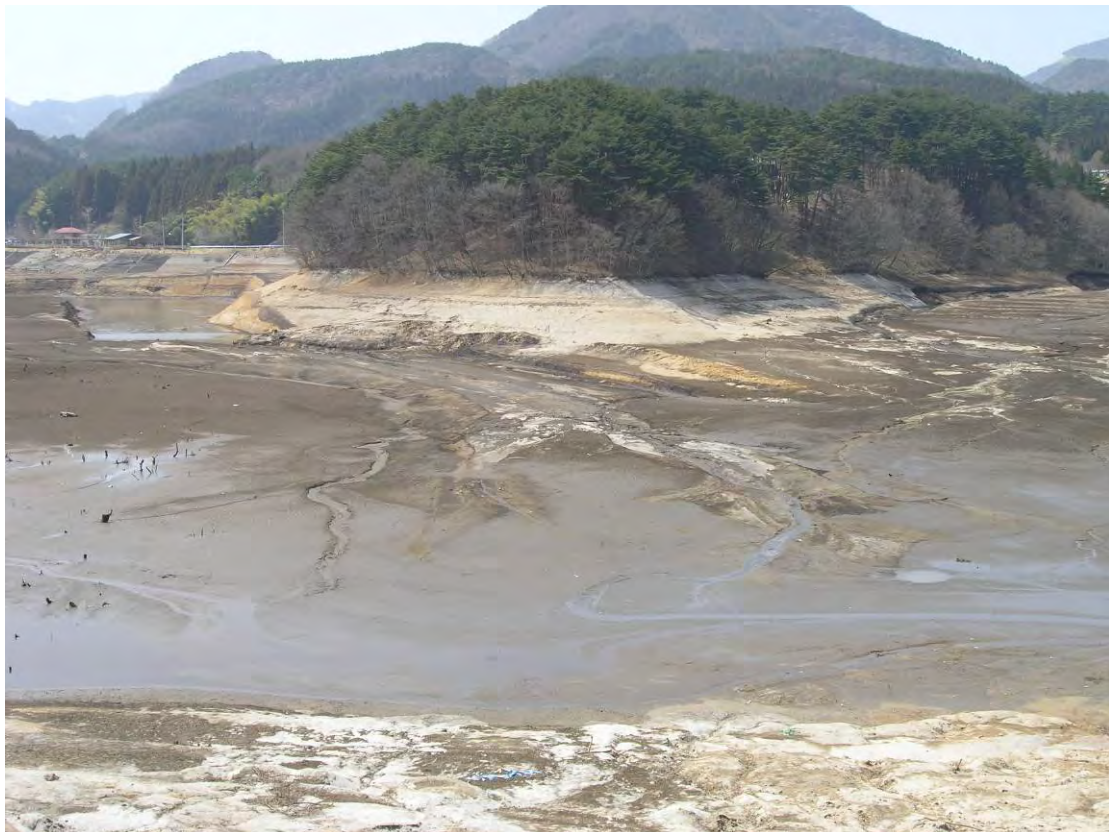
Fig. 40 Empty reservoir of Fujinuma Dam in Sukagawa City of Fukushima Prefecture

Fujinuma earth dam (Fig. 40) in Sukagawa City was constructed from 1937 to 1949. Its height was 17.5 m and the slope gradient was 1:2.5 on the downstream side, while 1:2.8 on the reservoir side. Being of uniform cross section, this dam was probably not well compacted because modern compaction machine was not available in those days. There were two dams here and No. 1 Dam was eroded and breached (Fig. 41a) and caused flooding of 1.5 million cubic meters of water. No. 2 Dam failed towards the reservoir but did not breach (Fig. 41b). The flooding torrent rushed downstream from No. 1 Dam through a narrow small valley (Fig. 42) and attacked a village (Fig. 43) to destroy houses where 8 people were killed.

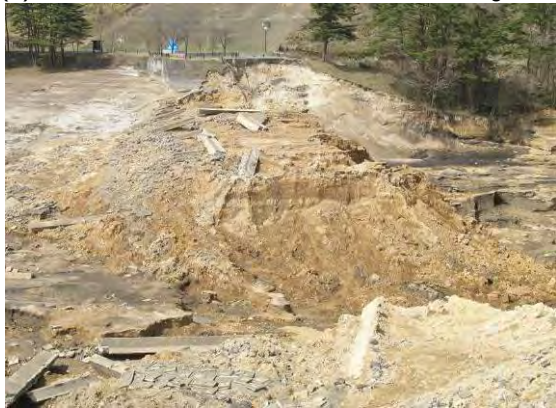
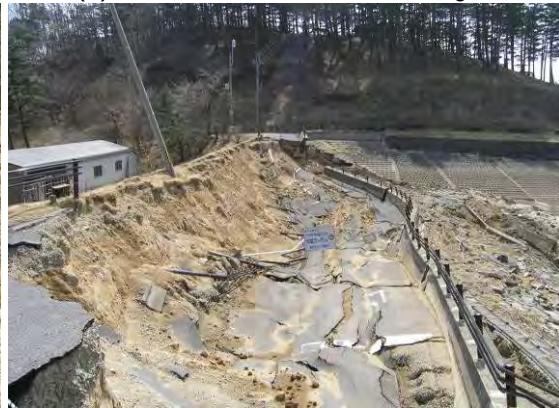
(a) No. 1 Dam after erosion and breaching

(b) No. 2 Dam without breaching

Fig. 41 Seismically breached Fujinuma Dam

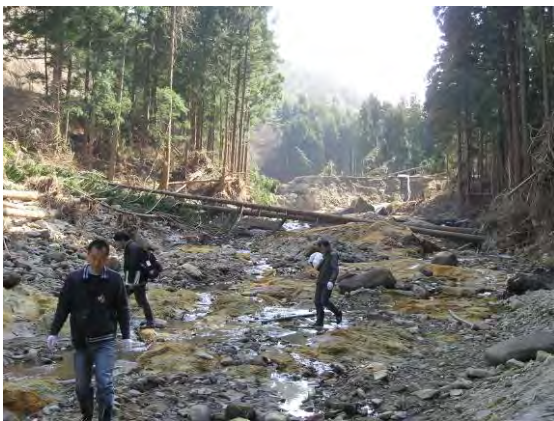
Fig. 42 Valley after torrent

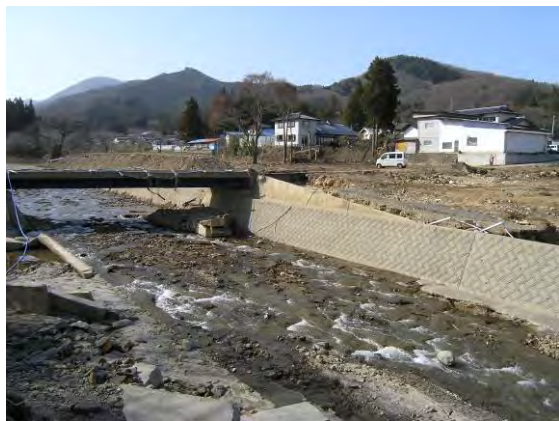
Fig. 43 Village attacked by flood

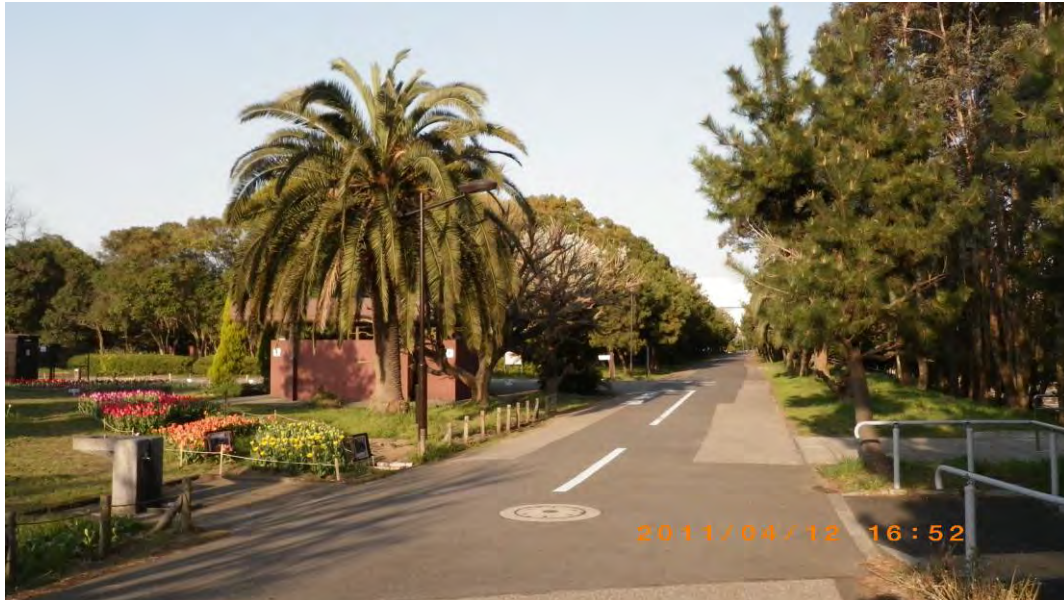
Fig. 44 Intact shape of municipal waste landfill at Yumenoshima of Tokyo

Concern was addressed to the behavior of a solid municipal waste landfill at Yumenoshima in Tokyo. As shown in Fig. 44, no subsidence or instability was triggered therein by the earthquake motion.
